5830  
Ser N00/151  
7 May 19

From: Commander, U.S. Fleet Forces Command  
To: File

Subj: COMMAND INVESTIGATION INTO THE DEATH OF ENS SARAH JOY  
MITCHELL, USN, AT SEA, ON 8 JULY 2018

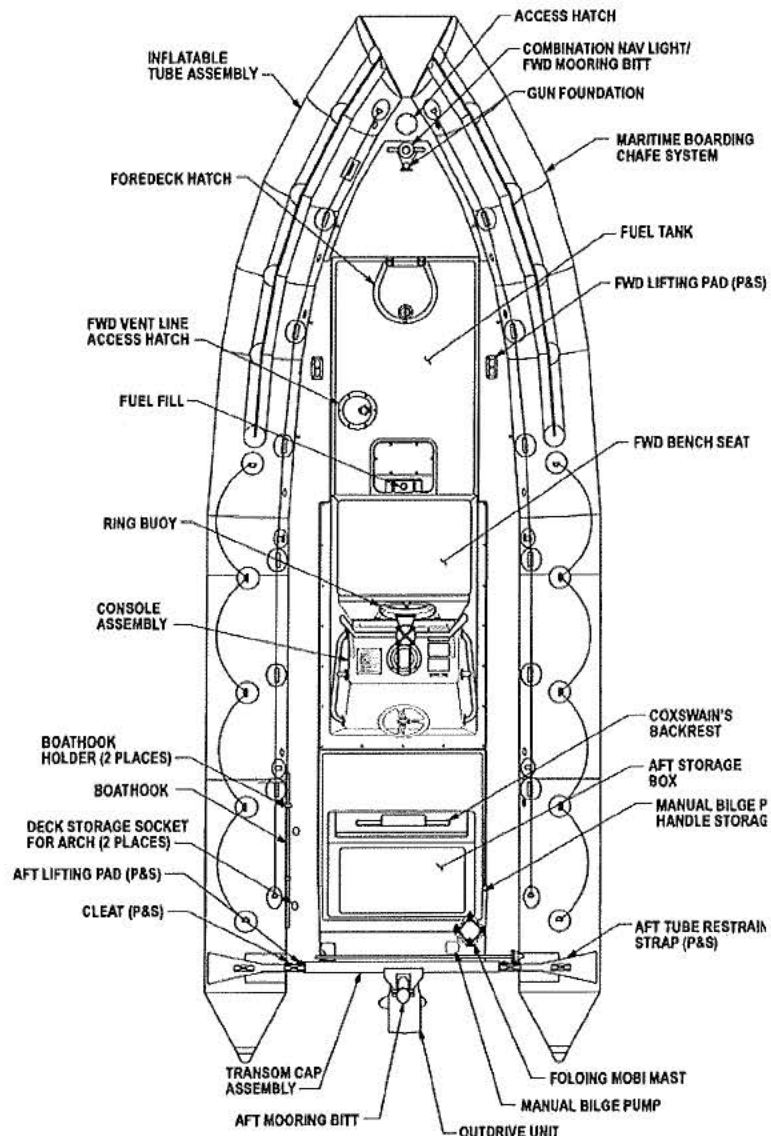
Figure 1, sourced from Reference (b)

77. Immediately before breaking away, ENS Mitchell directed personnel to hold onto the inboard line, see figures 1 and 3, between their legs when seated on the sponson. [Encls (28), (29)]

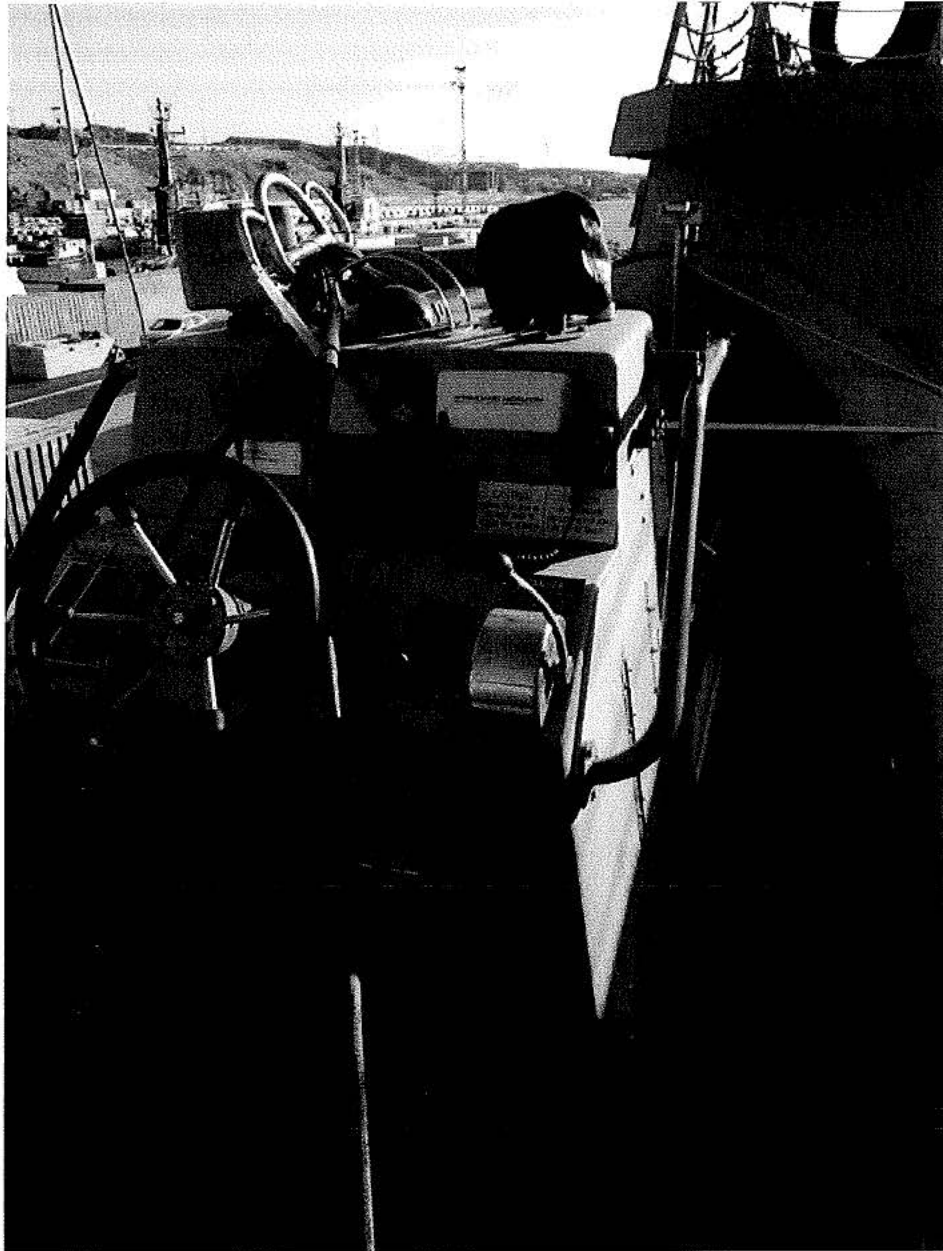
Figure 4, Investigator's photograph of helm

97. (b)(6) pulled himself up using the helm and started the turn to starboard to straighten out. He was not able to pull back the throttle before there was a second impact. [Encl (9)]

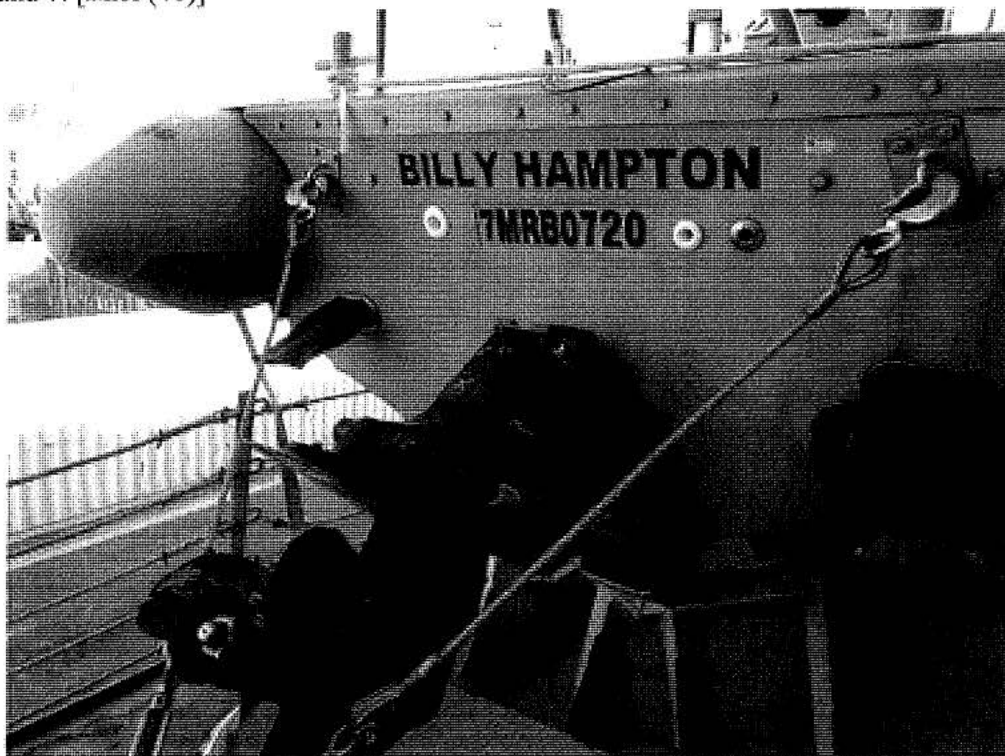
*Figure 6, Investigator's photograph of the RIB BILLY HAMPTON*

239. (b)(6) observed damage to the propeller of RIB BILLY HAMPTON. Specifically, he observed a gouge on the leading edge of one of the propeller blades and unknown fibers caught in the gouge, see figures 6 and 7. [Encl (48)]

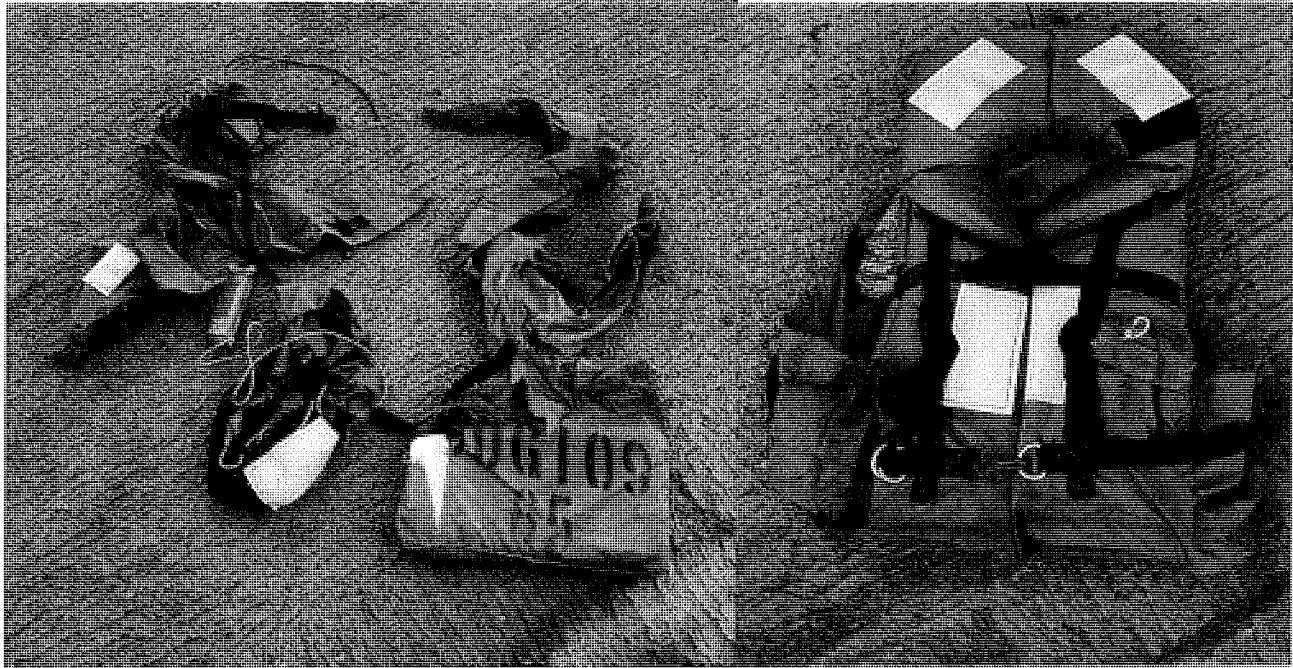
*Figure 8, Side by side comparison of ENS Mitchell's recovered lifejacket and an intact lifejacket (KAPOK)*

240. (b)(6) actions to throw ENS Mitchell's lifejacket into the RIB after unfouling the propeller preserved it for later review, see figure 8. [Encls (25), (45)]

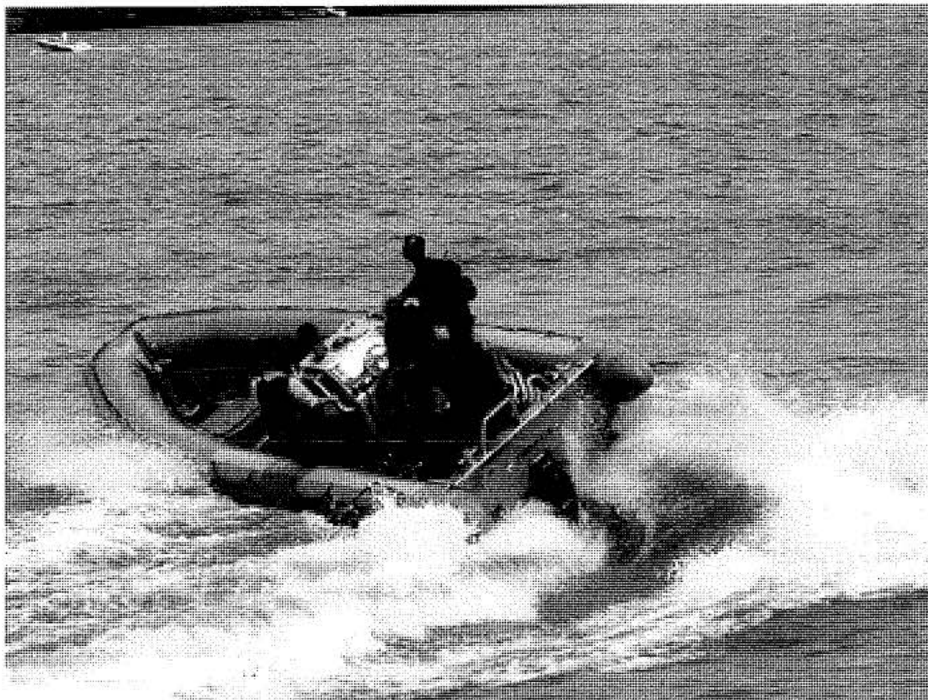
*Figure 9, showing a 7M RIB executing a hard turn, source Wikimedia Commons*

6. Hazardous maneuver. As a result of (b)(6) executing a full throttle, full turn to port, the RIB BILLY HAMPTON experienced a hazardous maneuvering event called "tripping" wherein the stern is temporarily airborne. Figures 8 and 9 below illustrate this effect. As a result of the coxswain causing the RIB to trip, four personnel were ejected at the time when the bottom of the RIB hit the water. Of note, the SAR swimmer self-ejected, bringing the total number of personnel in the water to five. The last person to be ejected was the Boat Officer, ENS Mitchell, a result of her forward position on the starboard bow and retaining a longer grip on the inboard lifeline. This caused her to pass directly under the RIB and being struck on the head by the outdrive, which inflicted severe head trauma and caused her death later that day. [FFs (78-87, 90-97, 293-294, 208)]
